# Phase 1 Desk Study Report

Site: Ewenny Road, Maesteg

Job No: TF-24-544-CA

**REPORT TITLE** : **Phase 1 Desk Study Report: Proposed Development, Ewenny Road, Maesteg**

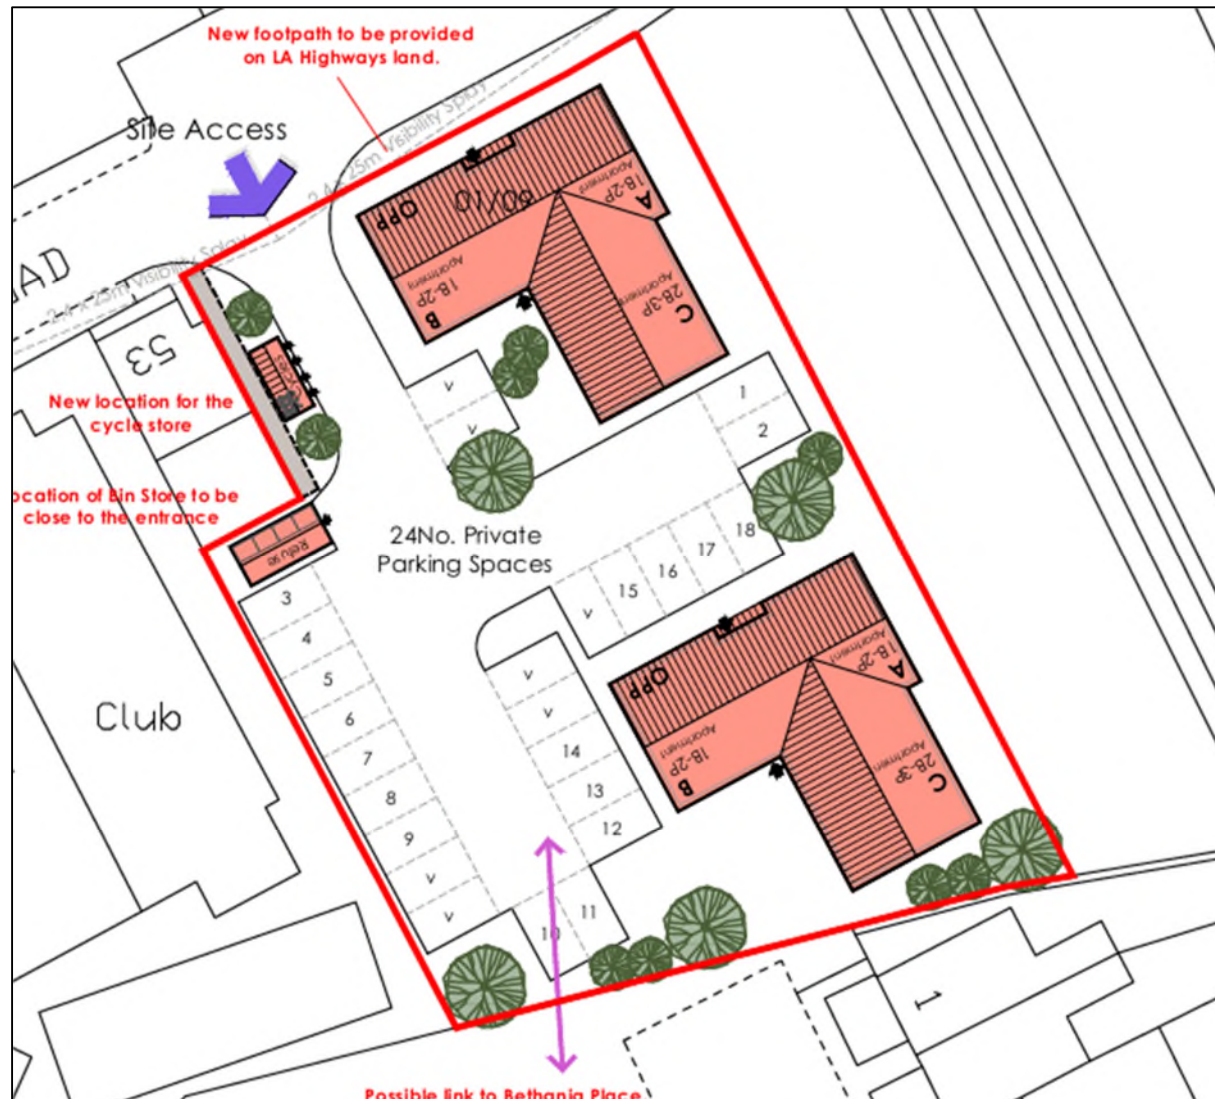
**Figure 1.1 Proposed Development**

The proposed layout of the development can be seen in **Figure 1.1**.
